## ADVANCED COMPOSITE WING COVER-TO-SUBSTRUCTURE ATTACHMENT (CTSA) DEVELOPMENT PROGRAM

Grumman Aerospace Corporation  
Bethpage, New York 11714

TECHNICAL REPORT AFFDL-TR-78-190

Final Report for Period July 1977 - November 1978

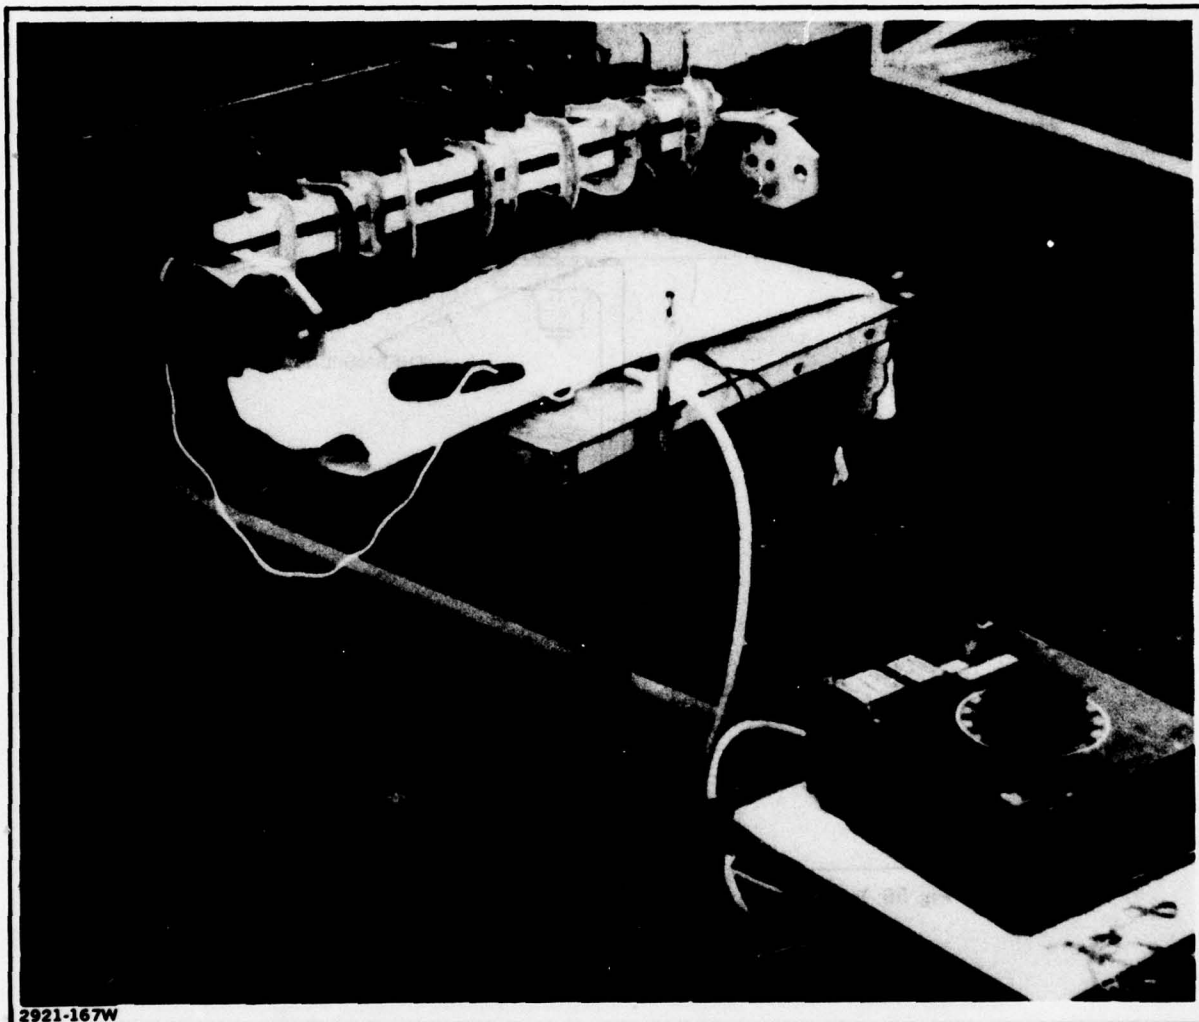
To minimize the loss of energy due to the steel ribs, they were coated with two layers of the thermoplastic seal. The upper cover was bonded using the resistance heating method (Fig. 57). Inspection of the bond was performed using a 0.001 inch feeler gage. A one inch long disbond was discovered at all four corners of the box

**Fig. 57 Resistance Bonding of Thermoplastic Adhesive**

(intersection of upper cover, front/rear spars and loading rib). This is only 2% of the total bond length (200 in.). Repeated tries to melt the unsealed area using the resistance heating method failed. This was due to the complexity of corner detail (i.e., steel rib - graphite/epoxy cover). It was decided to install the periphery fasteners and insert the test box assembly in the oven at 400° F for 15 minutes. This procedure was successful in sealing the four unsealed corners. Figure 58 graphically depicts the sealing sequence.

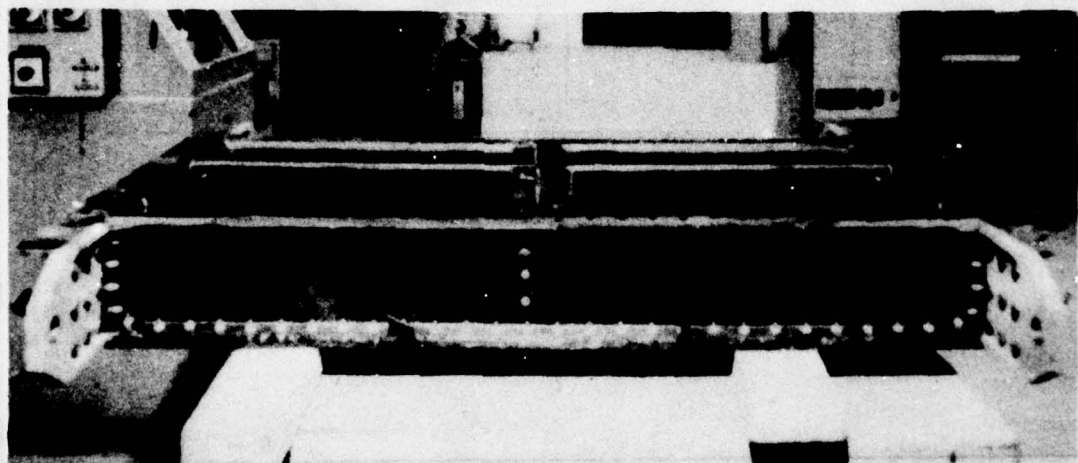
Figure 60 shows the upper cover and substructure after removal of thermoplastic bond.

Fig. 60 Test Box Showing Upper Cover & Substructure After Removal of Thermoplastic Bond

The upper cover and substructure were cleaned in a bath of Oakite before the rebonding operation. New graphite thermoplastic heating elements were made. Using the new heating elements, an attempt was made to bond the upper cover to the substructure. This was only partially successful because only the corners were bonded. The thermoplastic adhesive was melted only in the vicinity of the tabs where the temperature was in excess of 380° F. At a distance of eighteen inches from the tab, the temperature was only 180° F. Efforts to increase the 180° F temperature by increasing the amperage failed. The rises in temperature vs. current (amps) experienced are given in Table 13. These results show that the design of the graphite heating element tabs (Fig. 61) needs more development in order to solve the local overheating problem.

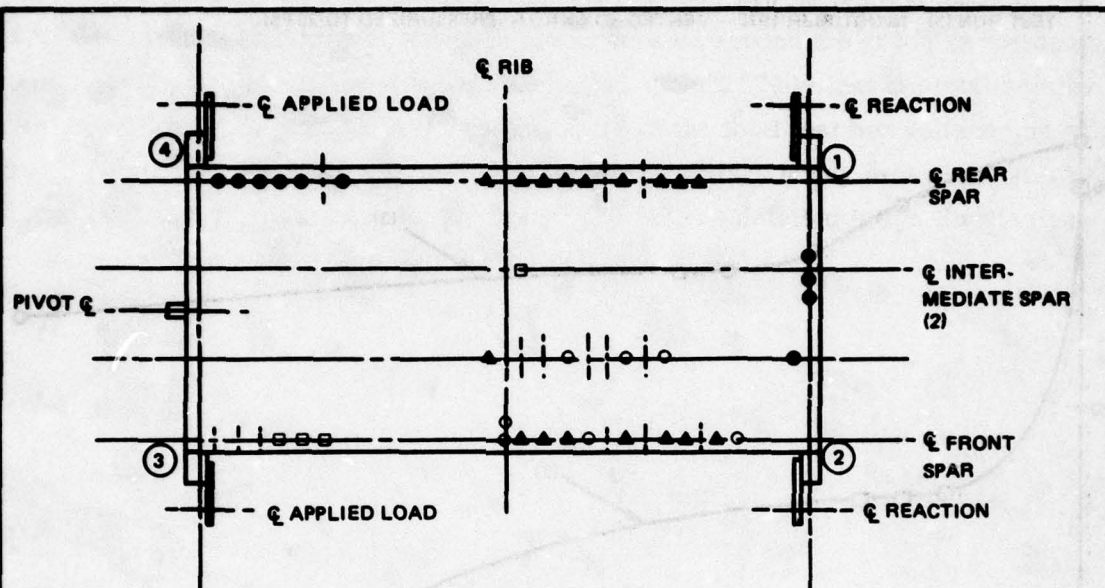
**Fig. 78 CTSA Test Box After 2000 Cycles of RT Fatigue**

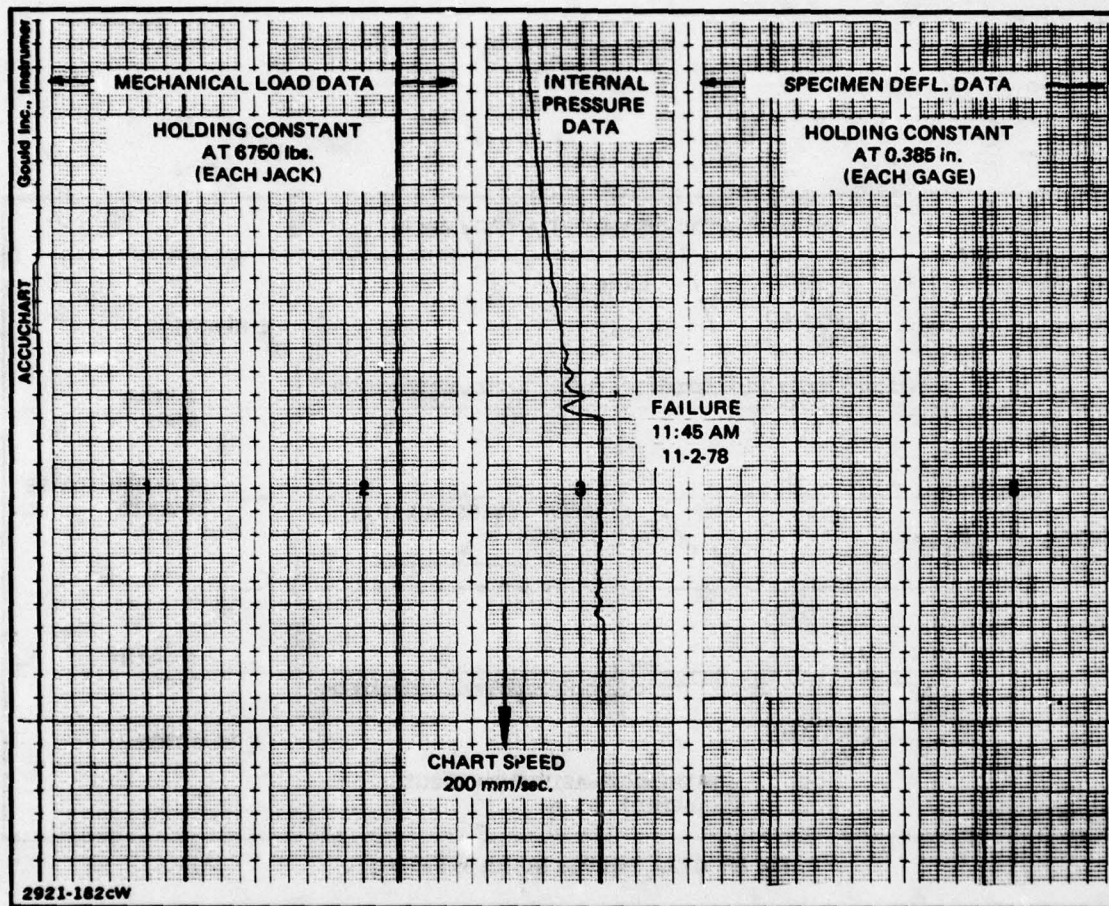
(C) Test Data at Failure of the CTSA Test Box

Test data recorded at the moment of failure is presented in Fig. 79C. A detailed inspection of the test specimen revealed the failure in tension of nine upper cover-to-intermediate spar fasteners and the extrusion of the thermoplastic sealing material along both the front and rear spar areas. Figure 80 is a sketch of the failure locations.

Fig. 79 Test Data (Sheet 3 of 3)
